TEST RESULTS OF THE IMPROVED 5DP-130 MODEL GIN IN PRODUCTION

Nurzod Yunusov
Independent researcher
Fergana State University

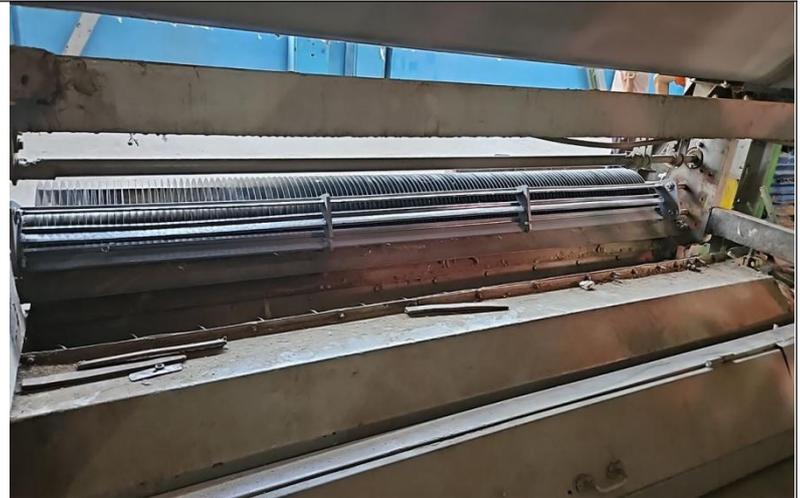
Figure 5. Assembled view of the 130-saw gin with an improved grate assembly.

1 – Saw cylinder, 2 – Improved grates in the grate assembly, 3 – Air chamber

The manufactured prototype was installed on one of the two 5DP-130 roller gins operating in the cotton ginning technological system at the Uychy Cotton Cleaning Plant of "Uchkurgan Textile" LLC in Namangan region. This gin was upgraded, and comparative experimental studies were conducted with a 5DP-130 roller gin equipped with the existing grate design (Figures 5 and 6).
